### PART 1 – Introduction

<b>Organisation involved</b>	Iarnród Éireann Infrastructure Manager (IÉ-IM)
<b>Occurrence synopsis</b>	<p>From the 27<sup>th</sup> February 2023 to 24<sup>th</sup> November 2025 there have been eight reported near misses between trains and IÉ-IM members of staff; carrying out activities such as track patrolling, infrastructure inspections and fault rectification.</p> <p>There were no injuries as a result of these occurrences, however, these incidents pose a serious risk to members of staff on the railway who could be hit by trains, causing injuries or fatalities to one or more members of staff.</p>
<b>Scope of USAN</b>	<p>The RAIU are currently conducting a trend investigation into these eight reported near miss occurrences, this investigation is ongoing.</p> <p>This USAN focuses on six of the reported near misses (two of the incidents, which occurred at Bray Tunnel No. 4 and Bray Tunnel No. 2 on the 6<sup>th</sup> December 2023 and 11<sup>th</sup> April 2025, respectively, were deliberate non-compliances, in that signal protection which was required to enter the tunnels, was not requested; therefore these are not included in this USAN; however, they will

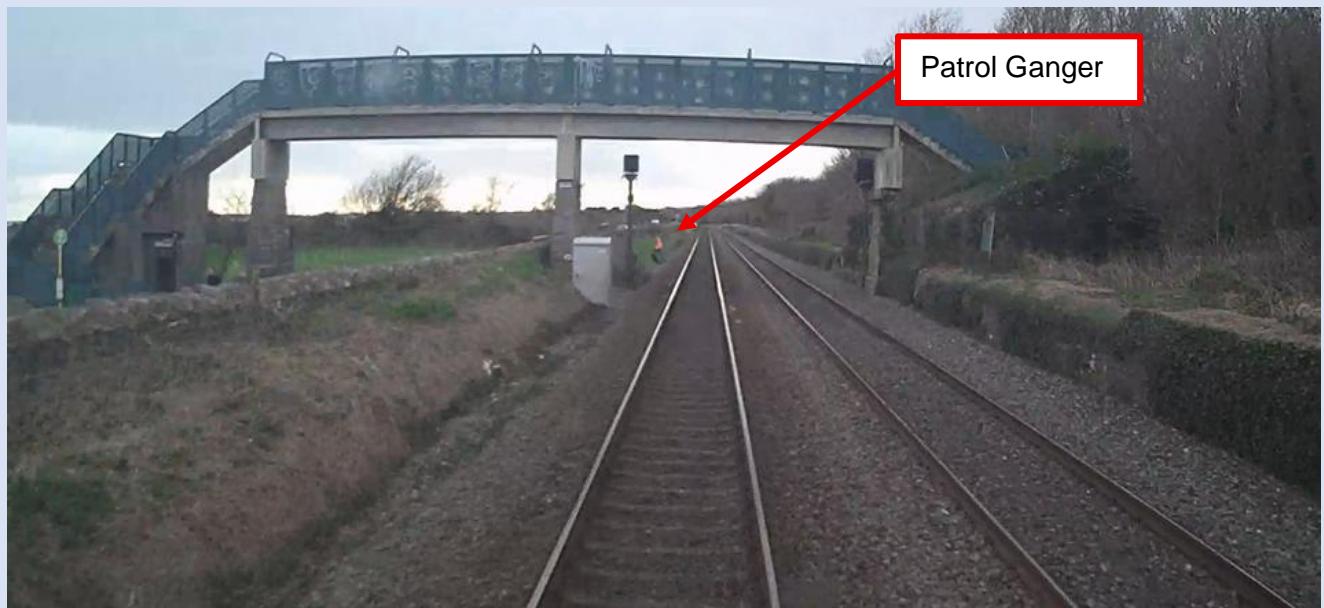
On the 27<sup>th</sup> February 2023 a patrol ganger was undertaking a track patrol; during the patrol, as the patrol ganger was bending down to inspect an insulated joint, a train approached through a shallow left-hand curve at 90 mph (145 km/h).

On seeing the patrol ganger, the train driver sounded the horn; on seeing the train, the patrol ganger moved to a position of safety, reaching it approximately two to three seconds before the train passed (see image below from the train's forward-facing CCTV (FFCCTV) below).

The sighting distance, for the location, was approximately 500 m, whereas the required minimum sighting distance, for the speed of the line, is required to be 700 m.

IÉ-IM have reported that a specific SSOW and risk controls for the Ardgillan area have since been implemented.

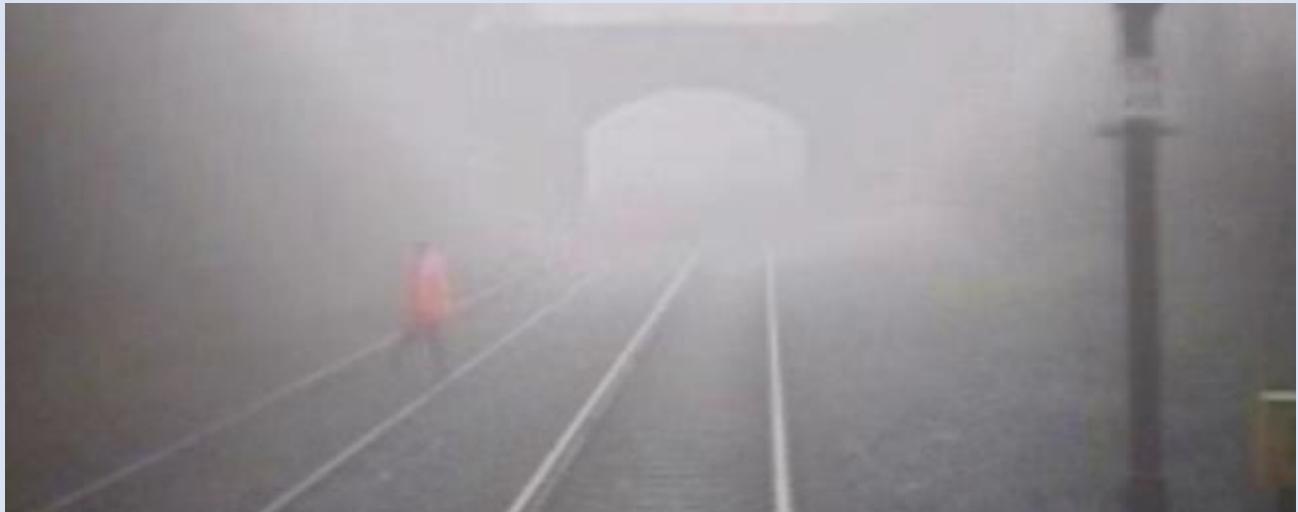
A train approached at 78 mph (126 km/h) with the train driver only seeing the patrol ganger as they moved clear of the line.

The patrol ganger saw the lights of the train (they did not hear the train) and stepped clear of the running line onto the adjacent siding (not a position of safety) approximately two to three seconds before the train passed (see image below from the train's FFCCTV below).

While the minimum sighting distances were achievable for the location in clear weather, the minimum sighting distances could not be achieved in foggy conditions.

At the time of the incident, the IÉ Rule Book did not explicitly reference what should occur when someone is working alone during fog or falling snow. Since the incident, the IÉ Rule Book has been updated to include instructions for TSCs, namely that during fog or falling snow, the TSC must arrange for the line(s) concerned to be blocked to all movements; or for an emergency speed restriction to be imposed to ensure that sufficient warning of approaching trains can be obtained by the Lookout.

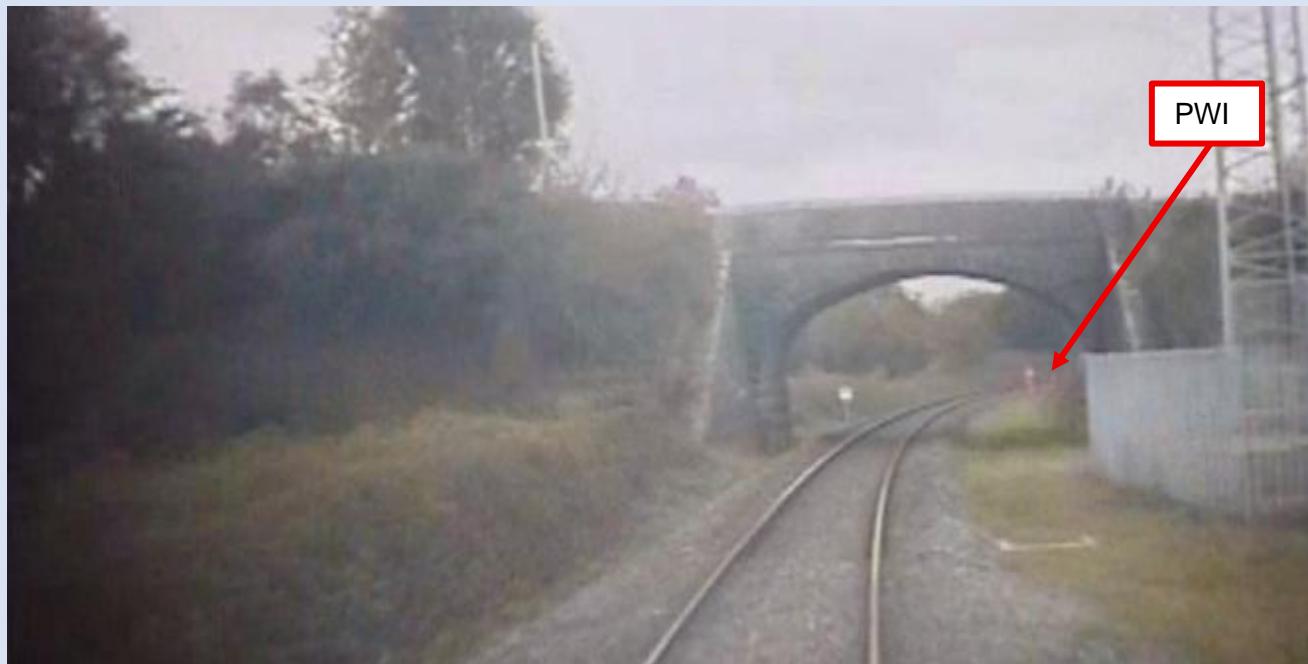
The railway at the location is a single line between Carlow and Muine Bheag with a maximum permitted speed of 80 mph (128 km/h). The required minimum sighting distance for the location is 700 m; however, at this location there is a curve (61 ¼ Milepost) with vegetation outside the railway boundary restricting sighting distance to less than 350 m.

As the PWI approached overbridge OBW 79, a train approached in the Up direction. The train driver saw the PWI on the line approximately seven seconds before reaching the staff member and immediately sounded the horn as well as making an emergency brake application. The PWI reached a position of safety around four and a half seconds before the train reached them.

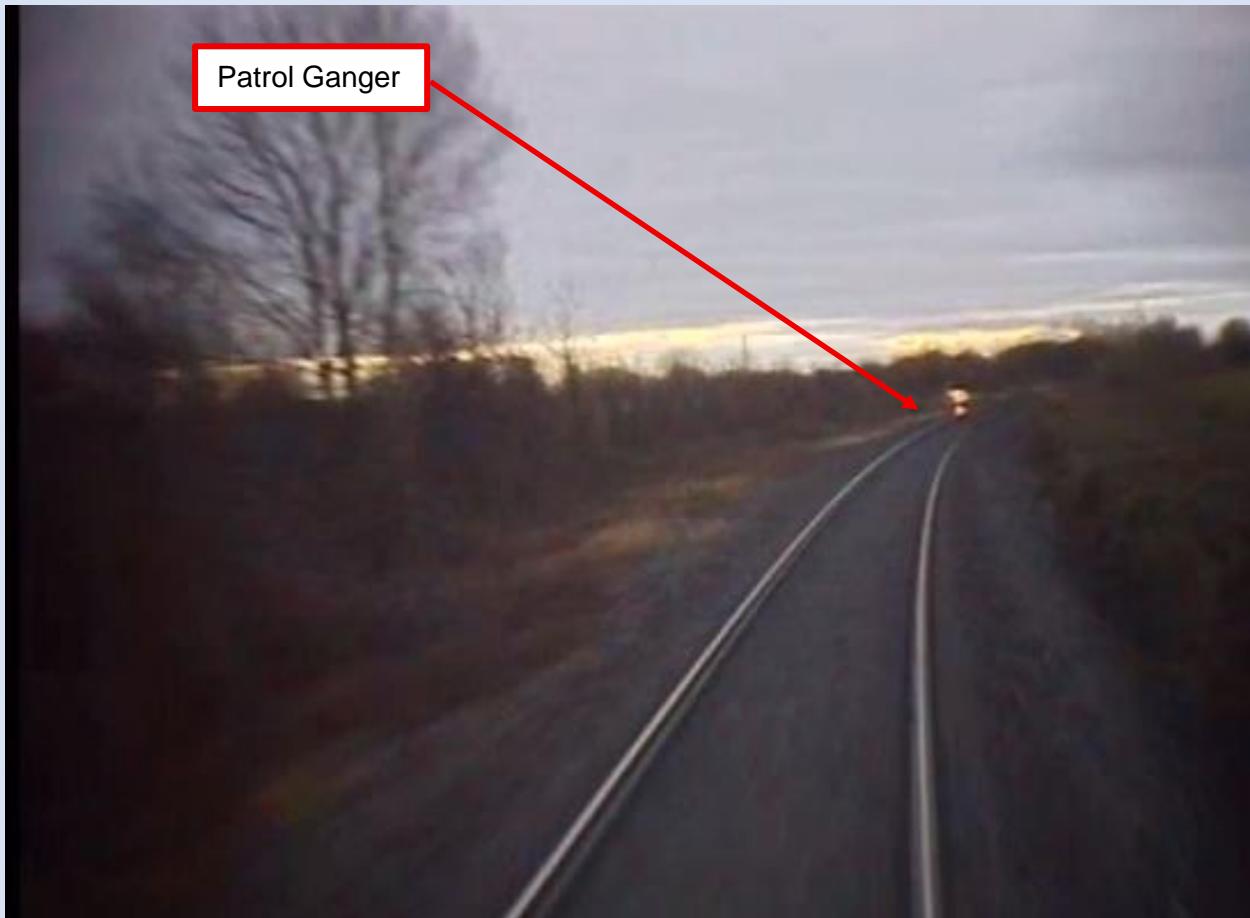
On the 24<sup>th</sup> November 2025 a patrol ganger was track patrolling; during the patrol the patrol ganger was walking in the Up direction in the five foot when they heard a train approaching in the Up direction (i.e. the patrol ganger had their back to the approaching train). The train was travelling at 79 mph (127 km/h) as it approached the location. The patrol ganger, on hearing the train, moved clear, but only reached a position of safety less than three seconds before the train arrived (see image below from the train's FFCCTV below).

The sighting distance, for the location of the Patrol Ganger, was approximately 190 m, whereas the minimum sighting distance, for the speed of the line, is required to be 700 m.
